Presenting  
**THE PROPERTY INSPECTORS**  
Pre-purchase Property Report

1 Sample Street  
Sampleville

**RE: Pre-Purchase Inspection: 1 Sample Street, Sampleville, Auckland.**

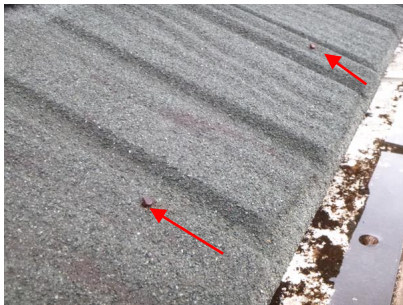
Bottom Row Tile Fixings were unsealed which can allow Water Ingress, example photo

Recommend sealing

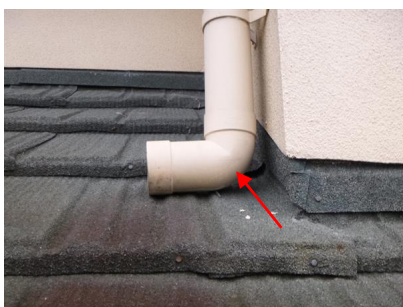
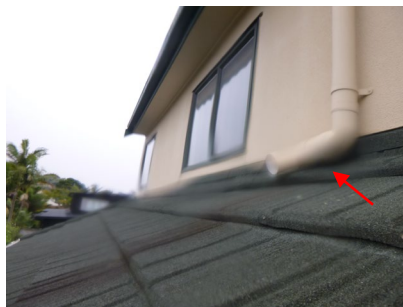
*These are required by the Building Code to assist the even displacement of Rainwater, example photos*

Recommend the installation of current Building Code Downpipe Spreaders to the Mid Roofs

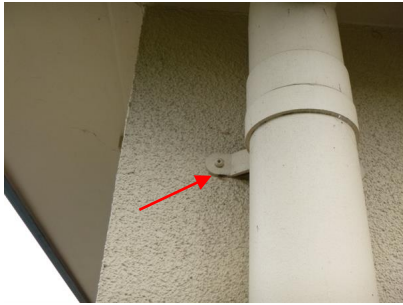
Downpipe Fixings to Wall Cladding

Appeared to be of an Unsealed Type, example photo

*These are known points of Water Ingress to the Cladding and structure of the Building although no evidence of this was found at the time of Inspection*

Recommend consideration be given to the installation of Sealed Type Fixings;

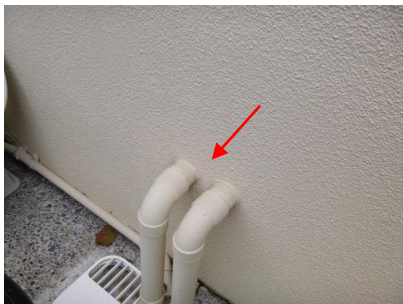
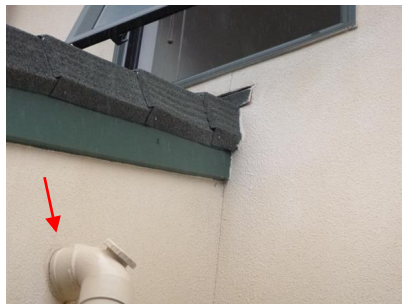
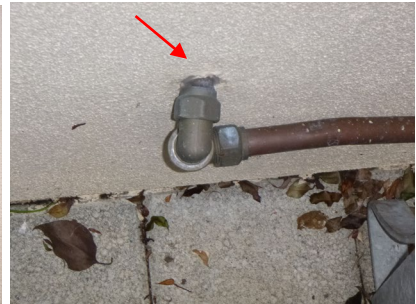
Penetrations through any type of Cladding and Roof can in some circumstances cause Moisture Ingress unless correctly flashed or sealed. Relying on Silicone Sealants as the sole method to seal Penetrations has been found to be unwise, recommend monitoring the condition of Silicone where used to prevent any possible Water Ingress

Recommend Flanges be installed at Pipe & Wall Junctions, example photos

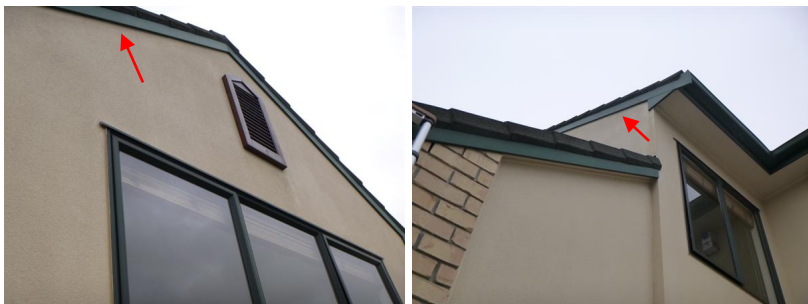
#### Varying Eave Widths

No Eaves in places due to design of the property  
Example photos

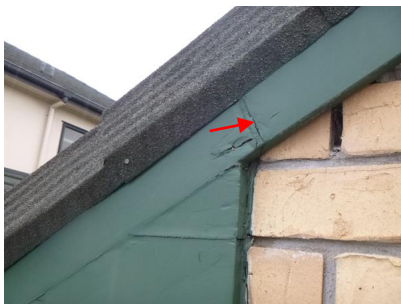
Moisture damage noted

At join

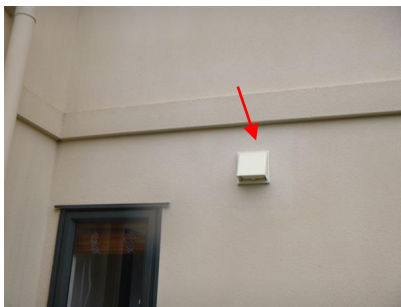
## No Mechanical Head Flashing

Above Vent Grille

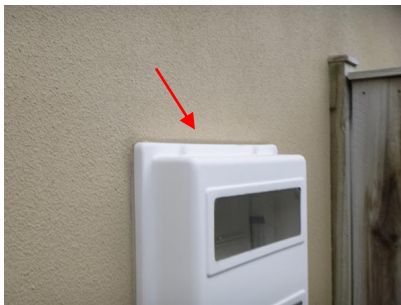
To Exterior Electrical Box as is now required

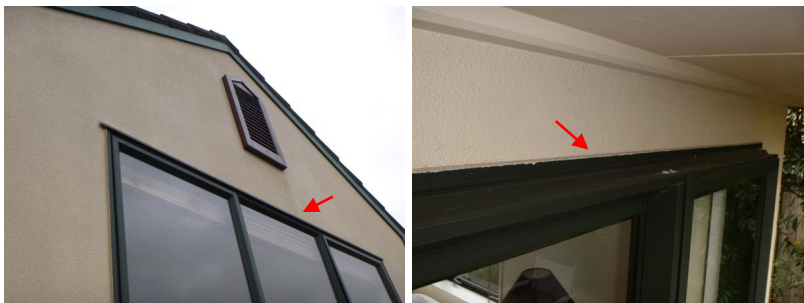
No Capillary Gap at the Base of Cladding with the Mechanical Head Flashings, example photos

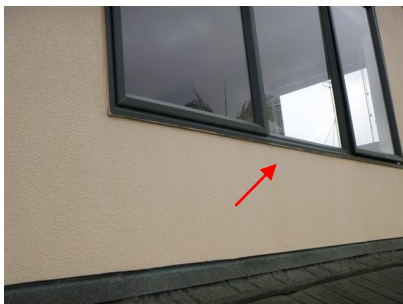
#### No Sill Flashings installed

Not a requirement at the time of inspection, example photo

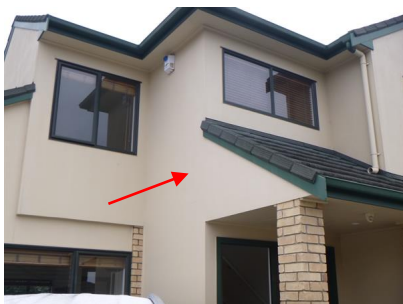
No Horizontal Control Joints as recommended

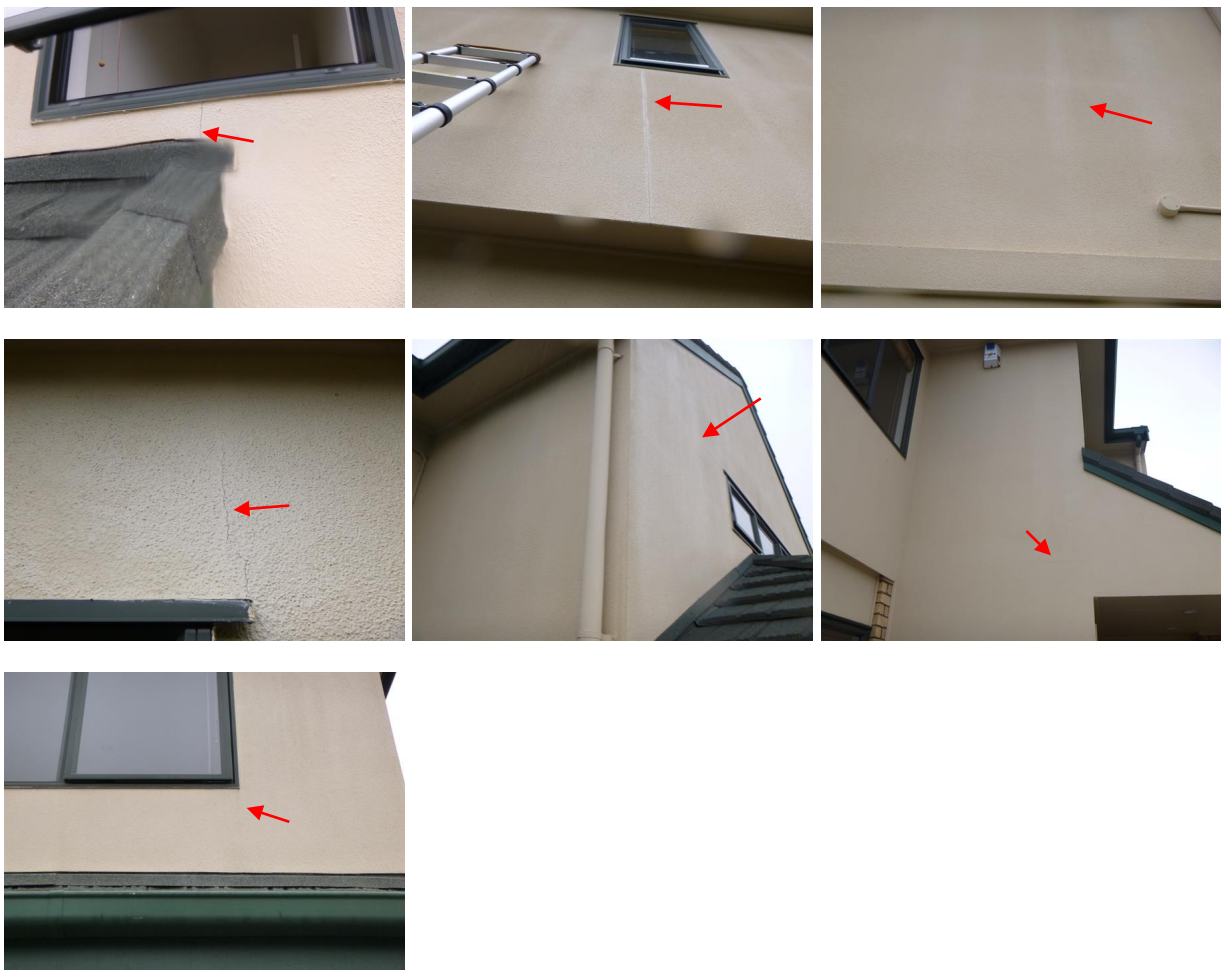
Cracks noted in many places which could allow Water Ingress

Unable to comment on the condition of the Framing in proximity to these areas

Recommend repairing as soon as possible by a suitable qualified repairer

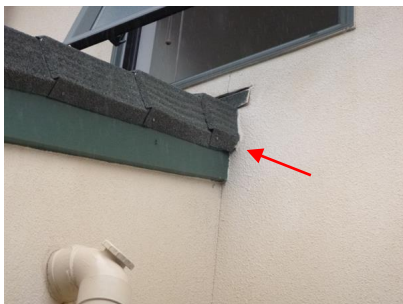
### Spouting & Fascia Stop End

Was buried beneath the Plaster Cladding, example photo

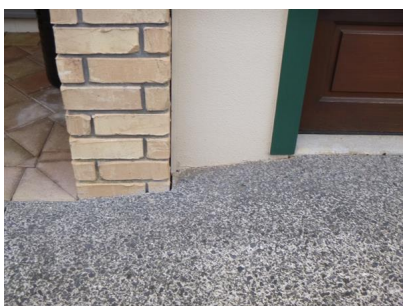
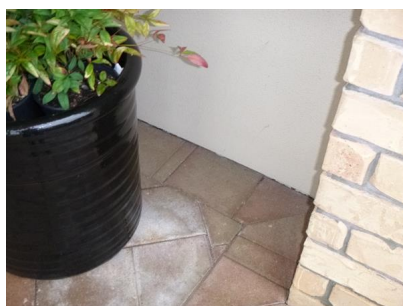
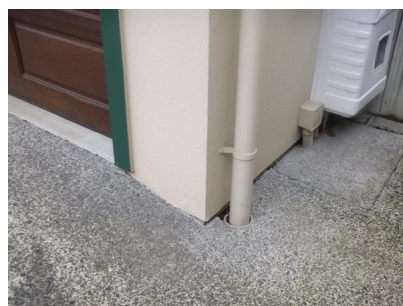
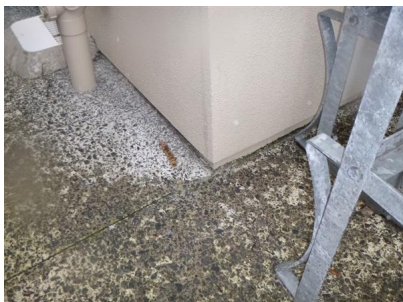
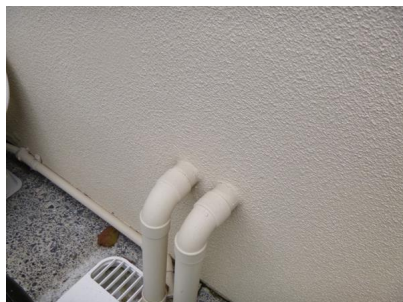
*Recommends the Base of Cladding be 100mm above Hard Surfaces, 175mm above Unpaved Ground. Damage to Buildings and Structural Frame and Internal Dampness are often the result of Moisture being sucked up from the Ground by Capillary Action behind Cladding. Under no circumstances should Cladding be carried down or below the Ground Level. Recommended that all areas be checked to ensure this clearance is observed*

Cladding noted to be near or buried below the Ground in places, this can allow Water to wick up behind the Cladding  
*Refer Building Code for clearance details, example photos*

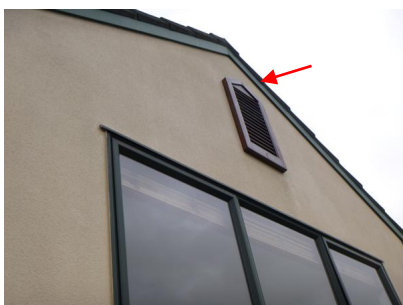
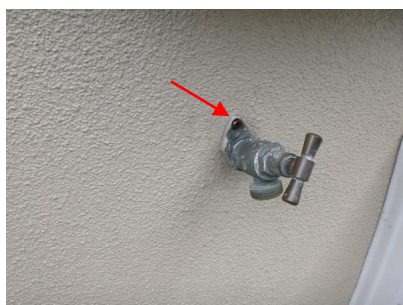
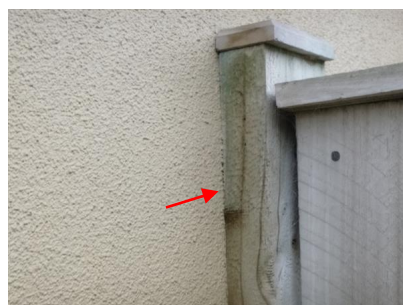
### Unsealed Fixings

Penetrating the Cladding are known areas of Water Ingress, example photos

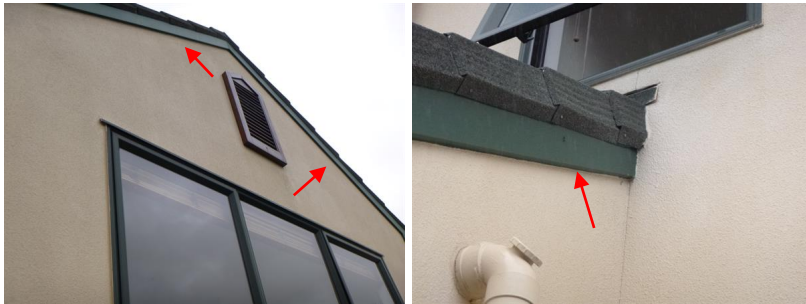
No Capillary Gap at the base of the Fascia and Barges with the Wall Cladding, example photos

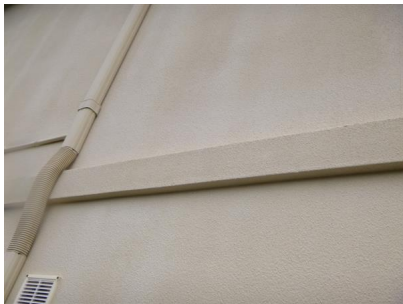
The Writer was unable to establish if there was a Mechanical Flashing or Control Joint behind the Decorative Band at the Inter Storey Control Junction

There was no Drainage Path at the Base of the Inter Storey Band, example photo

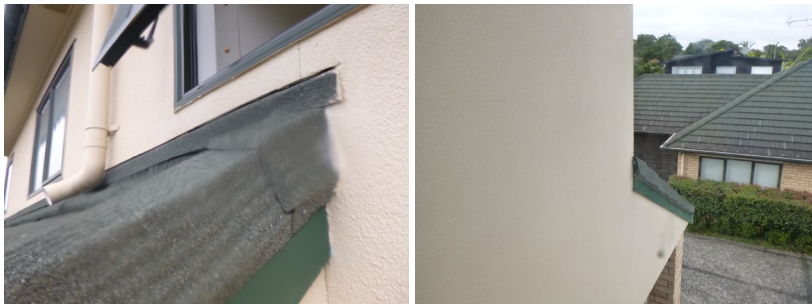
Are well known risk areas of Water Ingress if not Flashed or Sealed correctly, example photos

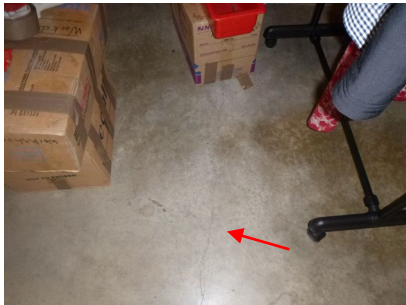
Cracking noted to the Garage Concrete Floor

Appeared historic and did not appear to be a major structural fault

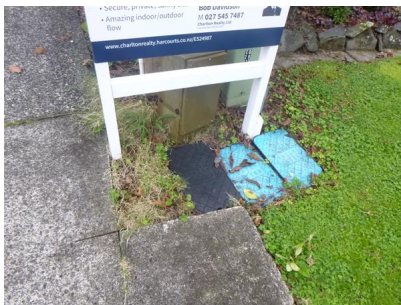
Water Meter located

At the start of the Drive

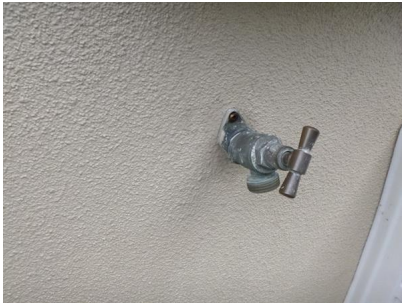
**Back Flow Valves not fitted to Exterior Taps**  
Recommend installing

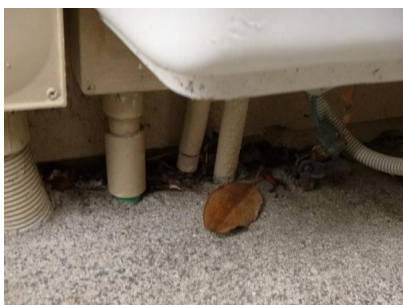
Supply Pipe was not isolated from the Concrete

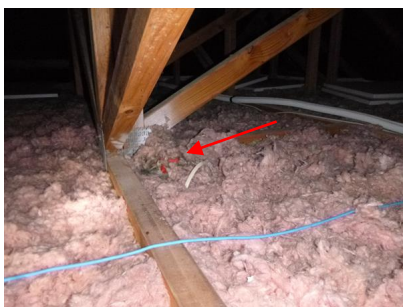
Insulation should be kept back from Downlights to the Manufacturer's Specifications to prevent heat build-up or be replaced with LED ICF Type, which allows Insulation to be installed over Light Fittings, example photo

Recommend over or near Down Lights

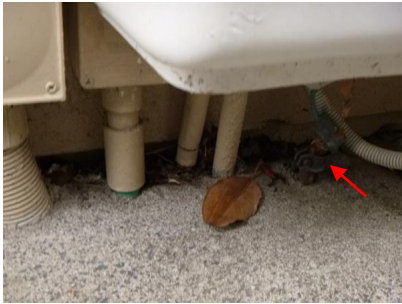
Concrete noted to have been poured around the Earth Pin;  
*Best practice would be to have Sleeve isolating the Earth Pin from the Concrete*

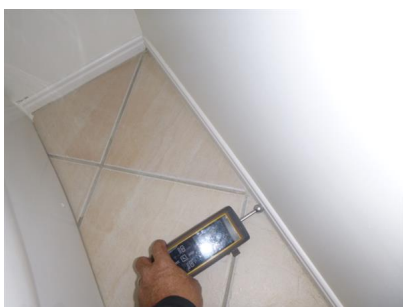
#### Elevated Moisture Reading

*Indicating a probable leak*

Elevated Moisture Level found to Wall Lining behind the Bathroom indicating a leak, further investigation recommended as the Shower may require to be repaired or replaced.

*Further investigation recommended*
